IAN BENNIE AND ASSOCIATES
TEST REPORT NO. 5004S1
GENERIC SYSTEM TESTING
TERRAÇADE TL CLADDING SYSTEM
PROTOTYPE TEST to AS/NZS 4284:1995
for The Austral Brick Company

TEST REPORT NUMBER 5004S1

Project: Terraçade TL Cladding System.

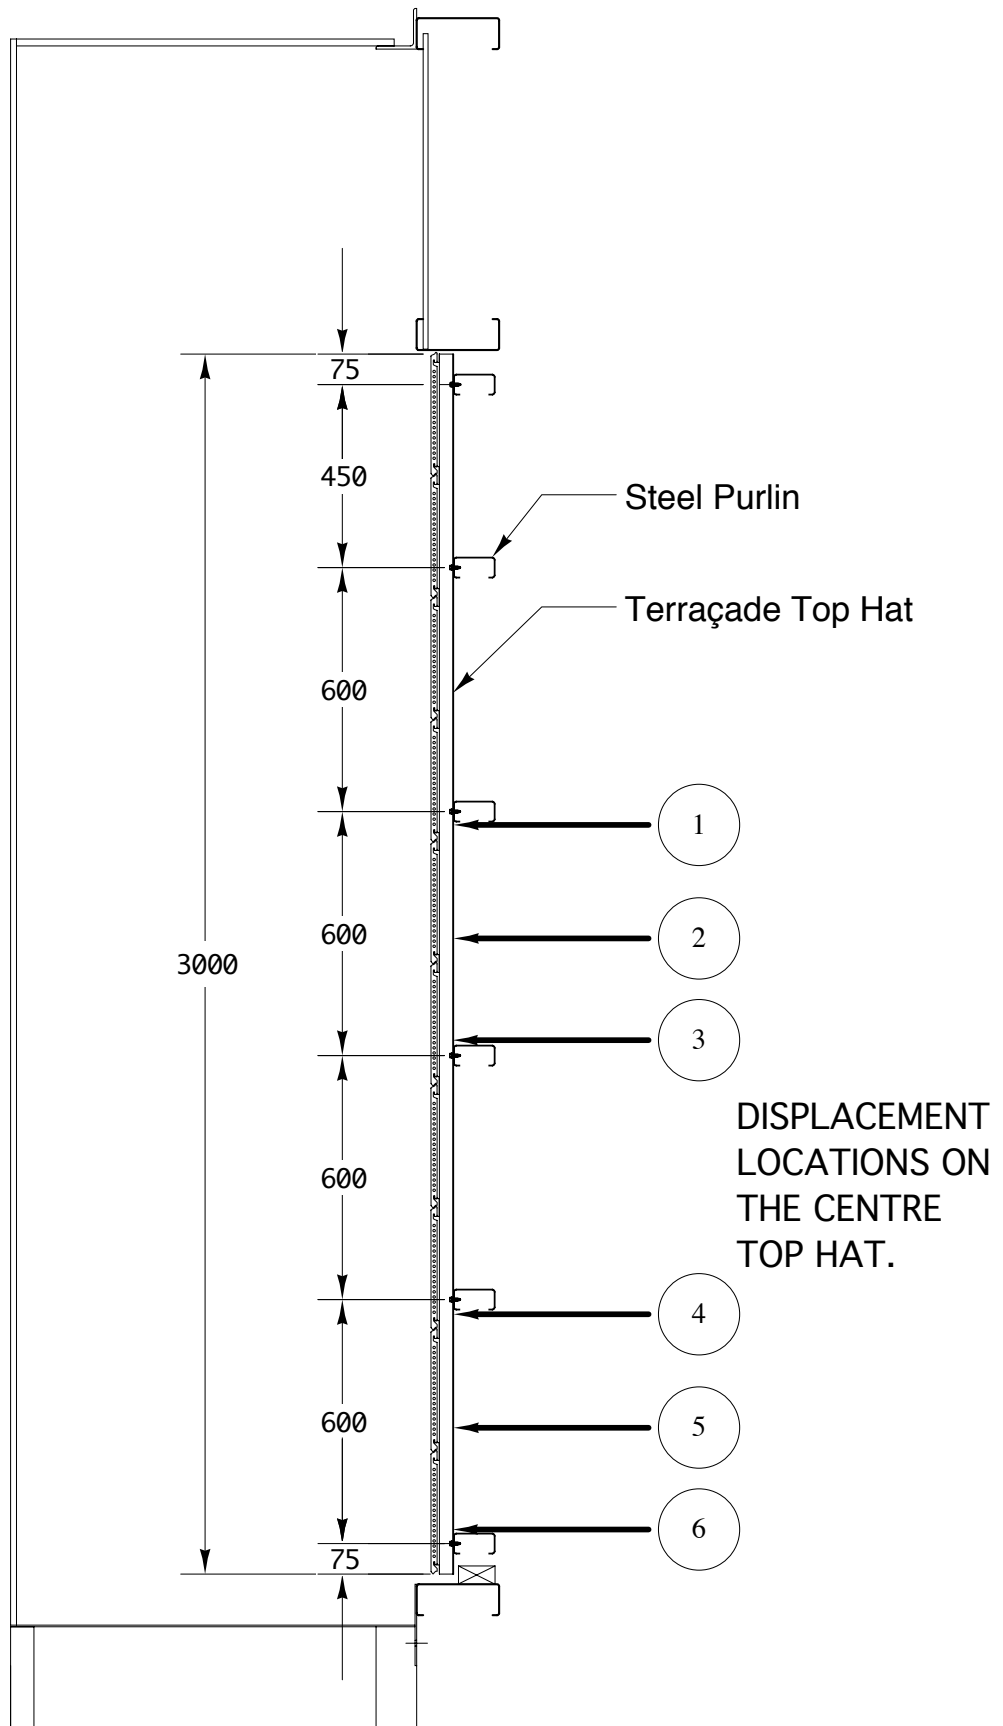
Figure 1. Displacement measurement locations.

Figure 1 shows the 6 measurement locations used to record the displacements under load of the top hat section. Table 1 gives deflection/span ratios for each span measured at each test pressure.

The greatest deflection recorded was Span:3067 at negative 1540 Pa.
