**IAN BENNIE AND ASSOCIATES**

**TEST REPORT NO. 2017-061-S1**

**TERRACADE XP – 600 MM  
WIND LOAD TESTS to AS4040**

**Brickworks Building Products**

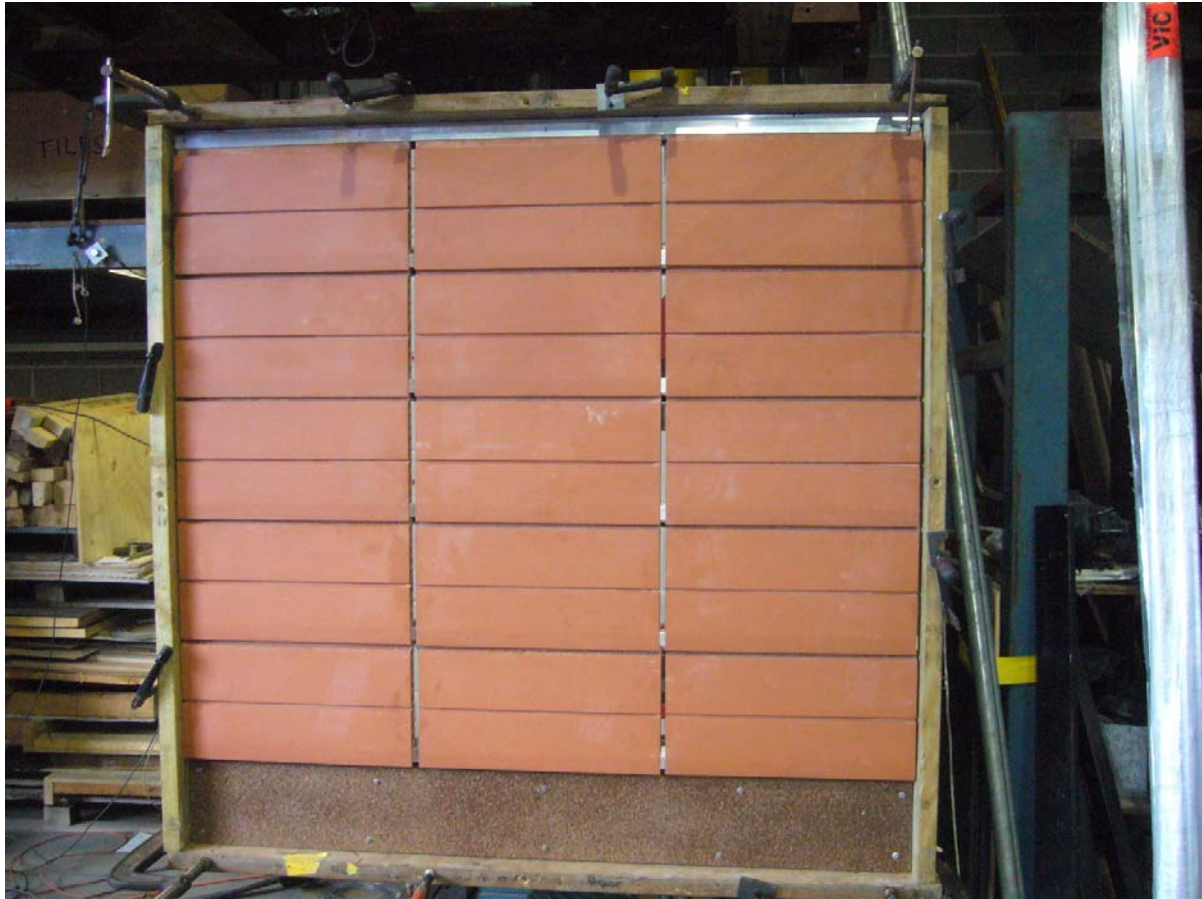
**Figure 1: Photograph of the test sample**

**Sample Identification**      A sample of Terracade XP – 600 mm was supplied for testing. The sample measured 1800 mm in width by 1500 mm in height and consisted of 3 tiles in width and 5 tiles in height. The tiles were mounted on horizontal suspension rails that were fixed to a timber sub-frame. Figure 1 is a photograph of the sample. All components of the sample were as detailed in the drawings provided by the Client that are given in Appendix A.

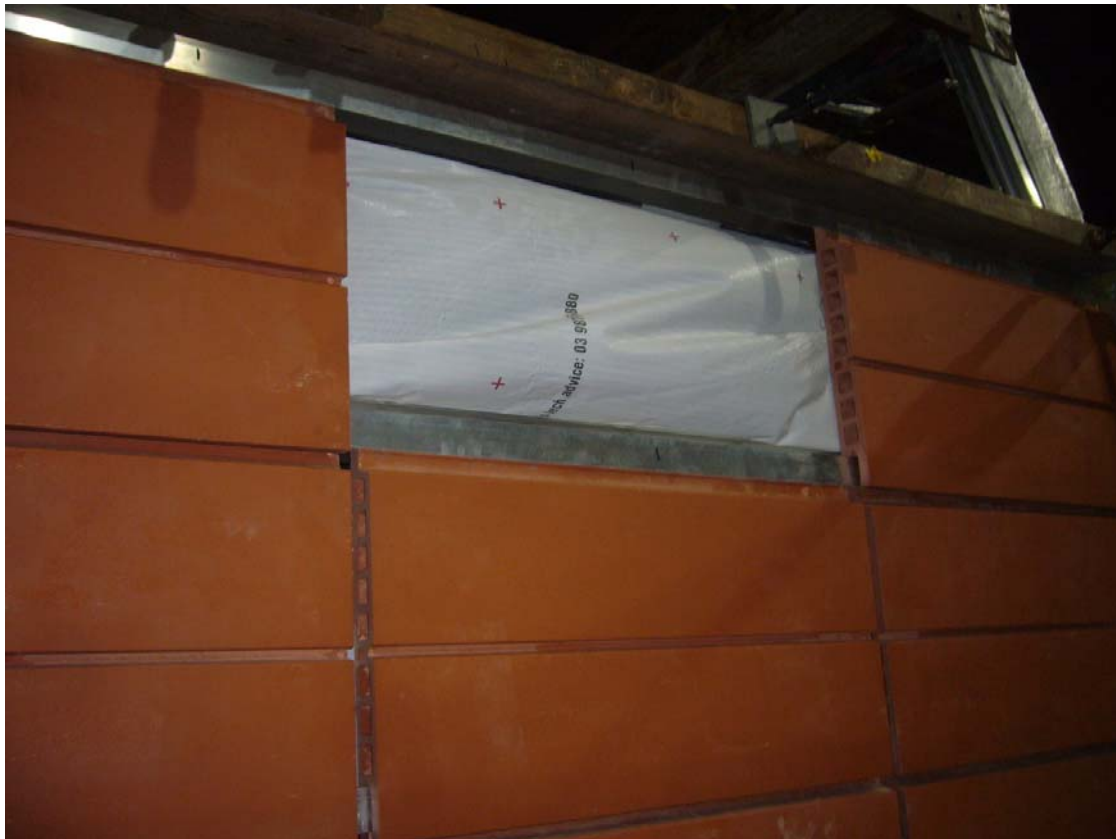
**Figure 2: Photograph of the sample after the test.**

When the pressure was increased to -6.2 kPa, the centre top tile released from the rails (see Figure 2). It appeared this tile lifted upwards and released along the bottom edge first as the engagement legs of the tile were not broken. The tile to the right of the released tile had also begun to lift up (see Figure 3)
